## North of 60

# Report on Municipal Services in Communities of the Northwest Territories NSRG 73-1

By G. W. Heinke

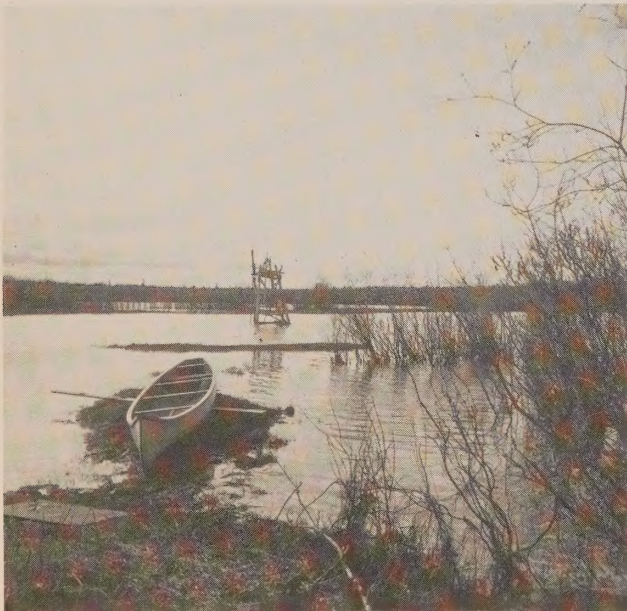
PHOTO A-1 – Pump Lake intake

Water is pumped at a depth of four feet from Pump Lake through about 950 feet of unprotected galvanized pipe to the water treatment plant (Photo A-1). This means that the system cannot function during the winter when water for the settlement is obtained from beneath the river ice.

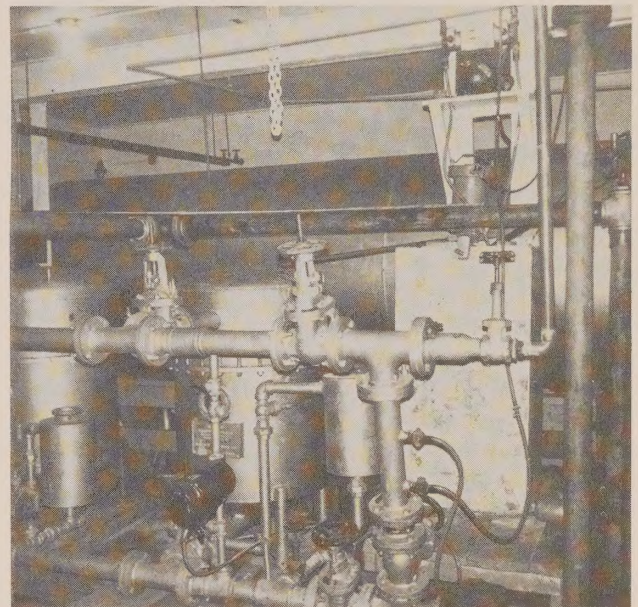
The water from Pump Lake is treated by diatomaceous earth filtration, chlorination and fluoridation. There are two diatomaceous earth filters, each rated at 50 gpm; but, due to a shortage of parts, only one was working at the time of inspection (Photo A-2).

PHOTO A-2 – D.E. filters and pressure tank

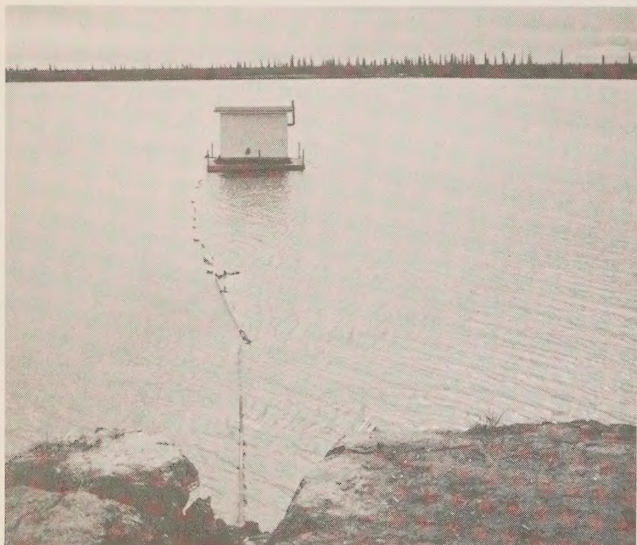
the ice ; but during breakup the river floods, and floating ice and debris will move almost anything in the way. Immediately after breakup, the silt content of the river is extremely high, a situation which eases until fairly clean water is obtained just before freeze-up. The intake house is anchored approximately 150 feet offshore in the summer and the intake positioned about 15 feet beneath the surface (Photo A-3). It is allowed to freeze into the ice in the fall, but is removed before breakup.

PHOTO A-3—Intake house in Peel Channel

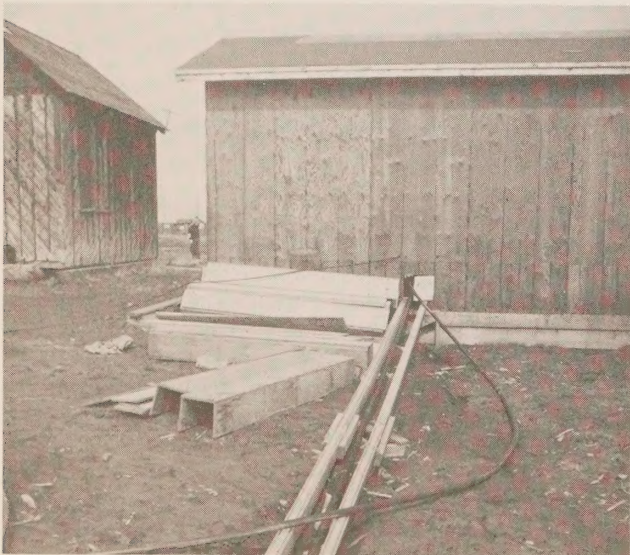
About two weeks after this system went into operation, the circulating lines in the insulated plywood utilidor leading to the pump house froze, and the entire system was out of service during the winter of 1969-70 (Photo A-4). This is to be solved by extending heating lines from the pump house to the intake house.

PHOTO A-4—Dismantled intake utilidor by pump house

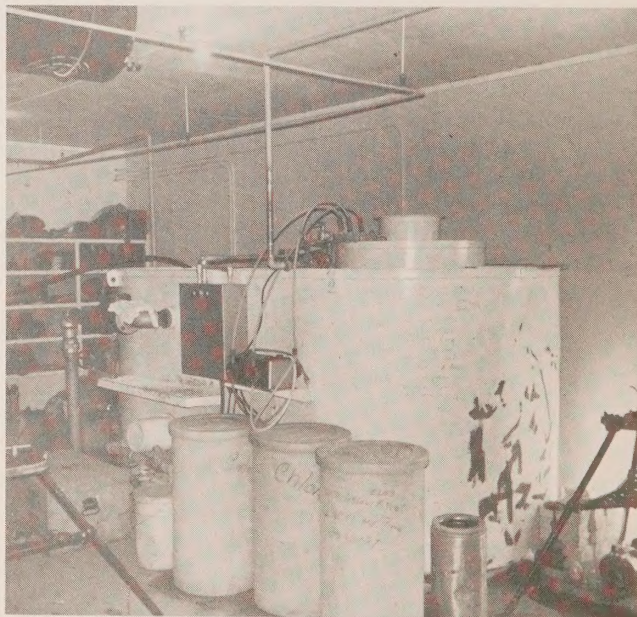
From the pump house, where the two pre-filters are to be installed, the water is delivered to the treatment plant through 1300 feet of insulated, heated plywood utilidor. The treatment unit consists of a Rotoflow package plant, rated at 10 US gpm (Photo A-5). Complete treatment (coagulation, settling, chlorination and fluoridation) is to be given in the summer ; in winter, only chlorination and fluoridation will be required.

PHOTO A-5—"Rotoflow" plant

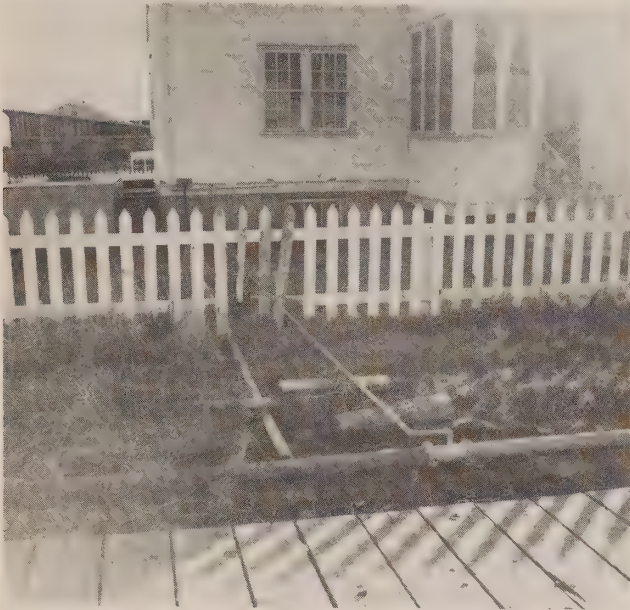
An extensive network of three- and four-inch galvanized iron piping provides a water distribution system for the summer. This network of pipes, laid on wooden blocks above ground, is buried or run through a culvert at road crossings. Victaulic couplings have largely replaced the old threaded connections. Taps are conveniently placed along the main line, and service connections may be made (Photo A-6). There is no charge for water distributed by this system.

PHOTO A-6—House connection to summer distribution system

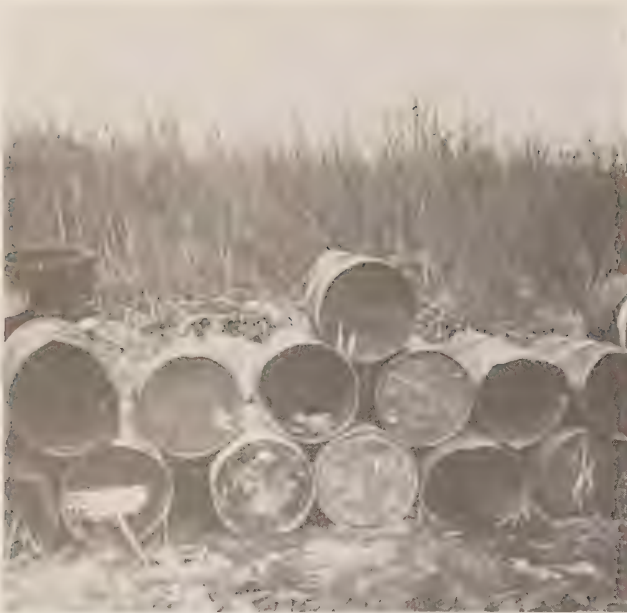
The remainder of the households use honey bags. There is a contract to provide pickup every other day using 45 gallon drums on a pickup truck, for disposal at the dump (Photos A-8 and A-9). The honey bags are usually put out with the garbage and are easily broken. There is no charge to the householders. The contract price is \$80 a pickup covering the entire settlement. Indiscriminate dumping of honey bags is discouraged, but still occurs.

PHOTO A-8 Honey bag collection barrels

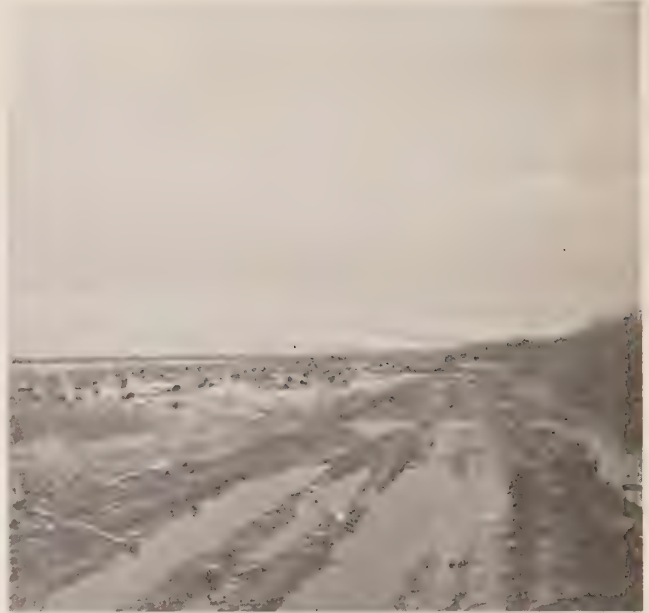
PHOTO A-10—Access road from dump

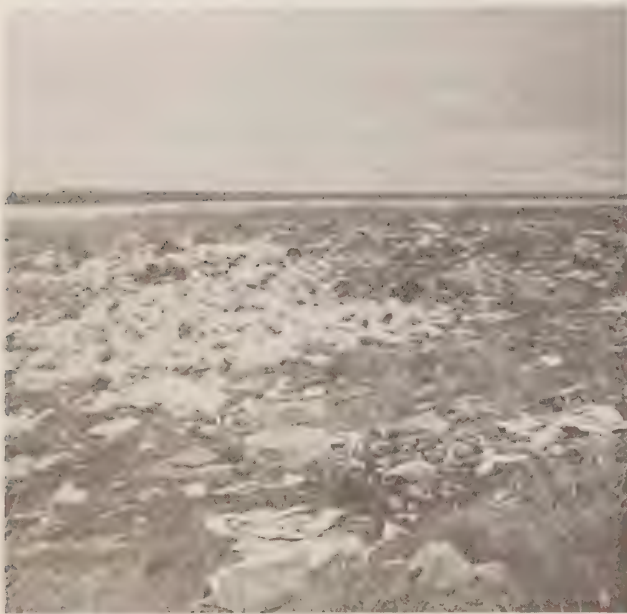
PHOTO A-9—Honey bag disposal at dump

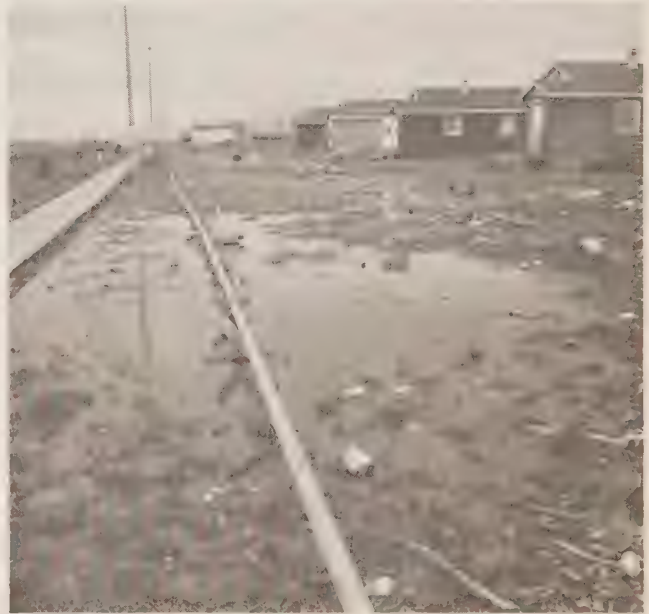
Waste wash water is disposed of directly onto the ground from buildings without sewage holding tanks. This adds to the drainage problems of the settlement, especially in areas with inadequate ditching. Ponding is not uncommon in these areas.

PHOTO A-11—Poor surface drainage

- The ditches and culverts should be better maintained, as recommended in the recent AESL report. Attempts should be made to drain low-lying areas.

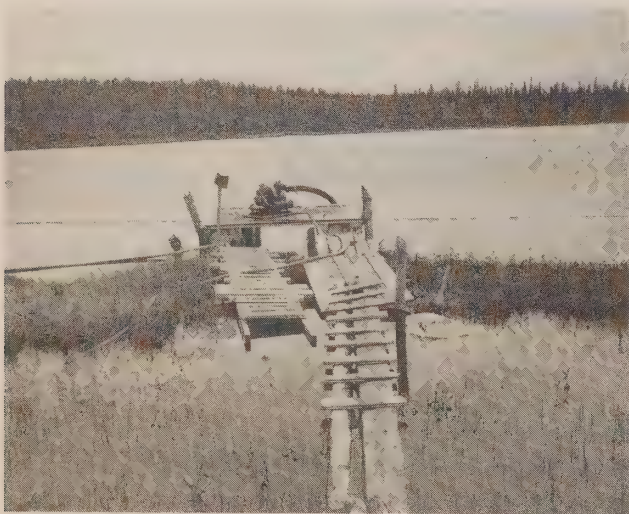
In the summer, and during breakup and freeze-up, water is obtained from a small lake 300 feet southeast of the school. Twice a week it is pumped by the Territorial power plant directly to a 1,000-gallon fibre glass tank near the centre of the settlement (Photos ARR-1 and ARR-2) from which residents fill their water buckets directly. The water is not chlorinated. A combination of 2-inch fire hose, 2-inch galvanized pipe with vic-taulic couplings, and 1½-inch PVC piping is used to deliver the water which is moderately hard (114 mg/l as  $\text{CaCO}_3$ ) and coloured (60 units) Grainge, (1968). In the spring it is more highly coloured due to organic matter in the runoff.

PHOTO ARR-1 – Water supply pump

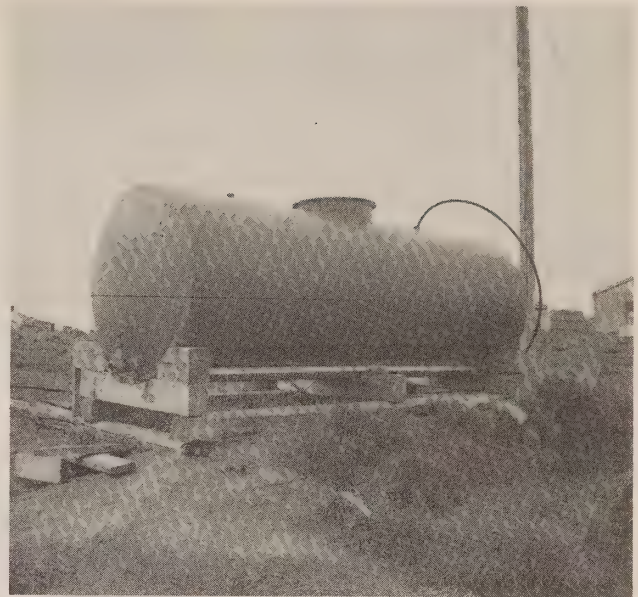
PHOTO ARR-2 – Water storage tank

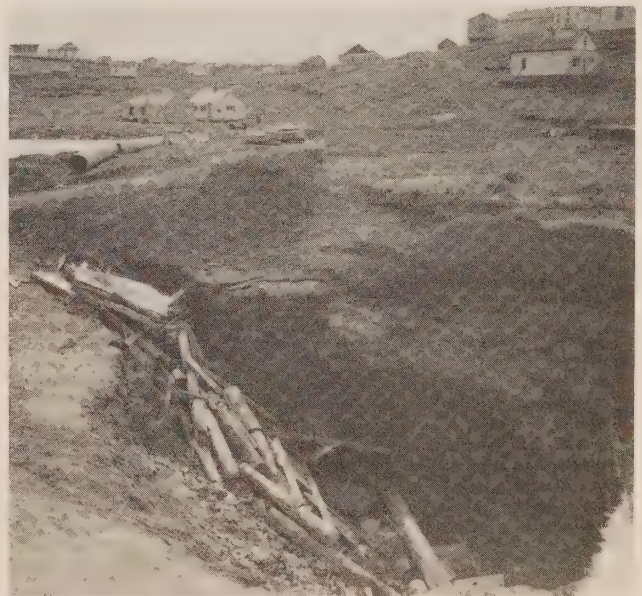
Garbage is collected once a week by the Territorial government, using a farm tractor and a wagon during the summer, and a TD9 (Cat) and a skid in the winter. The service will be incorporated as part of the Territorial power plant operator's duties. Disposal is along the north beach or haphazardly (Photo ARR-3).

PHOTO ARR-3 – Garbage disposal near river

- An organized garbage dump should be started at an isolated site, possibly along the CNT road. Care must be taken that the dump is not within the watershed of the water supply lake. Regular burning of combustible garbage and covering of the residue and honey bags would be necessary.
- Pickup of honey bags from within the houses should be started during the summer.

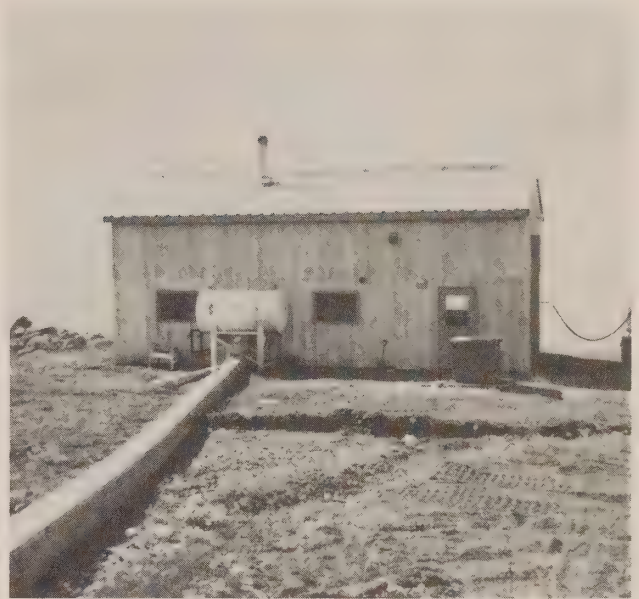
PHOTO BL-1—Water pumping station.

Water is drawn through a 600-foot intake line to a wet well beneath the pumphouse (Photo BL-1) where it is pumped, in two stages, to an on-grade reservoir six feet in diameter and ten feet high, and to a pressure tank. The system is supposed to employ two, one-horsepower electric low-lift pumps, connected in parallel and used alternately; but at the time of the site inspection, one two-horsepower motor was being used. Water is distributed to the nursing station and to the MOT complex by a two-inch diameter copper pipe in an insulated utilidor (Photo BL-2). The MOT

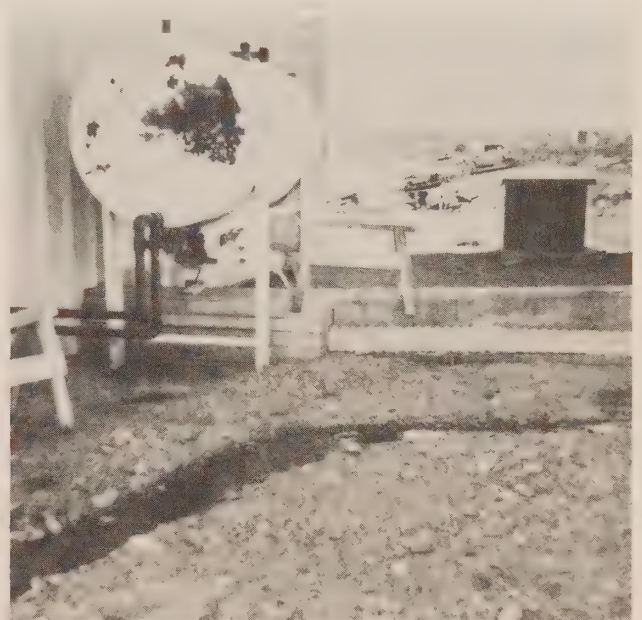
PHOTO BL-2—Upper utilidor: to Nursing  
Lower utilidor: to MOT.

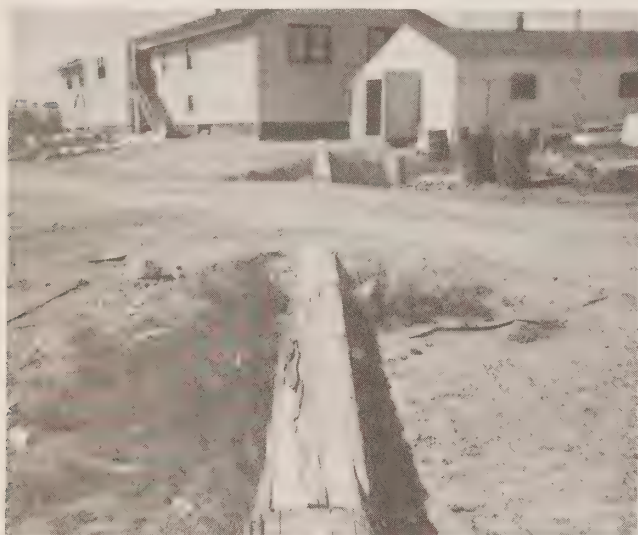
complex has an insulated, corrugated steel box structure, buried in the ground ; the nursing station is served by a wooden square-box, on-grade utilidor (Photo BL-3). The system depends on recirculation and heating with Pyrotenax heating cables to maintain flow at extreme winter temperatures. During the winter of 1970-71 the line to the nursing station froze on several occasions. Return water is pumped through a heat exchanger in the pump-house before re-entry to the utilidor.

PHOTO BL-3—Utilidor to Nursing Station.

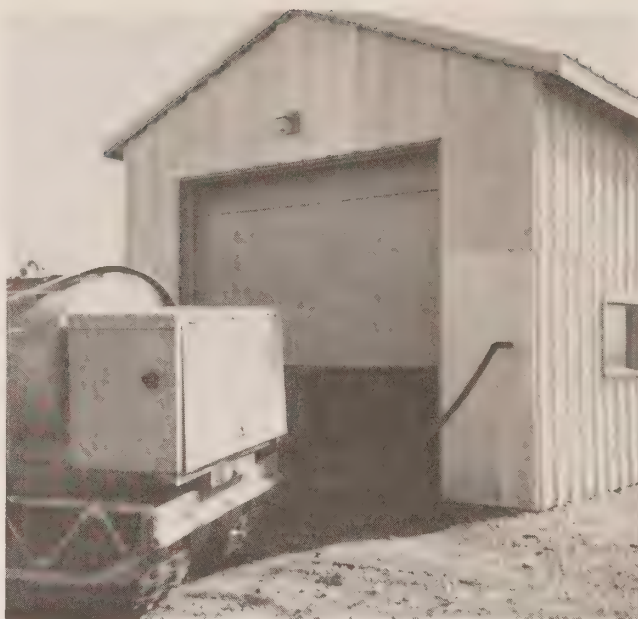
PHOTO BL-4—Water vehicle filling.

The water vehicle is filled at the pump house by an electric pump using a 3-inch diameter rubber hose which is left lying on the ground beside the pump house between filling operations (Photo BL-4).

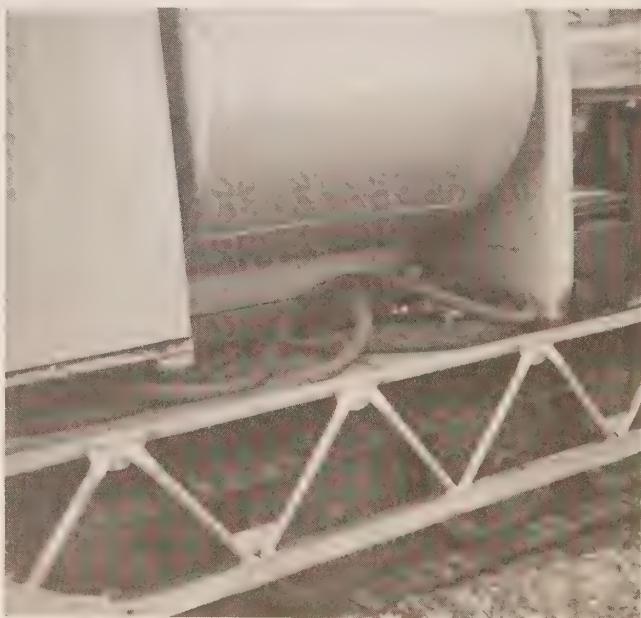
Using a gas-operated pump, water is pumped from the 500-gallon tank on the water vehicle. All deliveries are metered and recorded by a Neptune Print-O-Matic meter. Between deliveries, the hose and nozzle lie on the platform of the truck under the exhaust pipe (Photo BL-5).

PHOTO BL-5—Hose lying on platform of water vehicle.

Water samples are taken monthly by the nursing station personnel. It was reported that the samples from home tanks had been satisfactory, while the samples from the nozzle of the Nodwell water vehicle have had "slight" coliform counts. The usual health problems of diarrhea and vomiting, which may be attributable to the water, have also been reported.

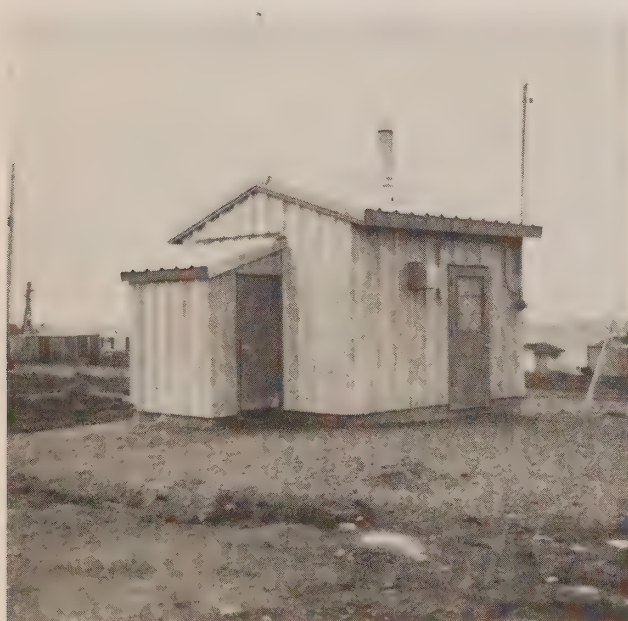
PHOTO BL-6—Water point building.

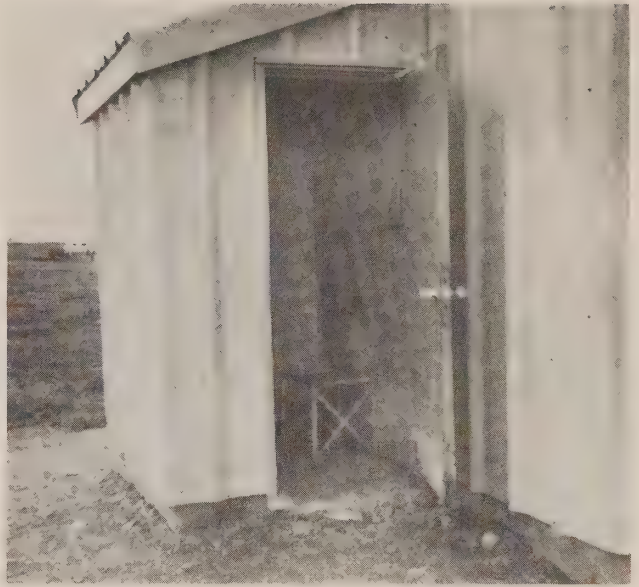
PHOTO BL-7—Water point heated compartment.

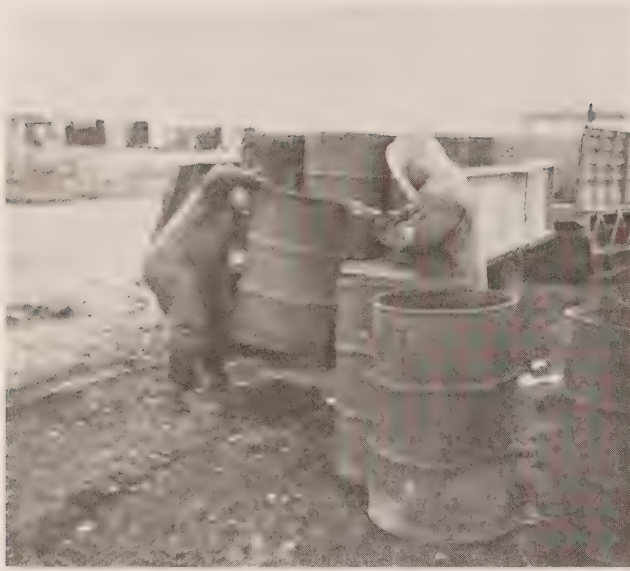
Honey bags and garbage are collected on a daily, street-by-street basis. Two men perform the operation, using a Muskeg cargo carrier and a wagon trailer. Each home has two 45-gallon drums into which honey-bags and garbage are supposed to be placed. The men lift the full drums onto the cart (Photo BL-8) and replace them with empty drums. The full drums are taken to the disposal site, dumped, and returned to the settlement for re-use.

PHOTO BL-8— Garbage collection.

After the 20 or so empty drums on the cart have been replaced by full or partially-full drums, garbage is collected from the remaining homes by dumping their contents into partially-full drums already collected. In this transfer operation, some refuse is inadvertently spilled on the ground, and a few honey bags are punctured.

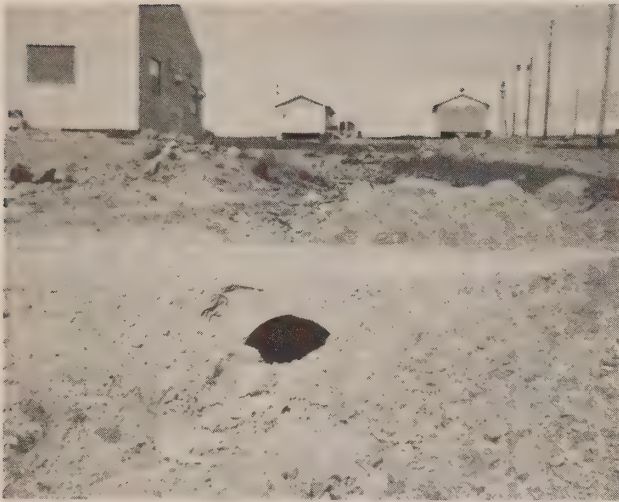
PHOTO BL-10 – Culvert under main road.

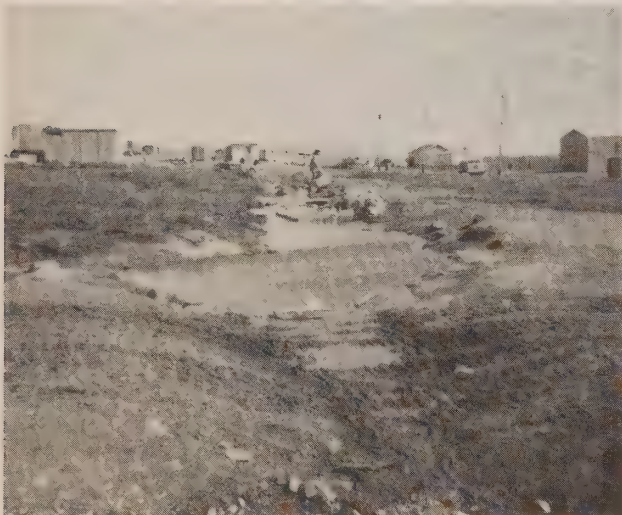
PHOTO BL-11 – East-west drainage ditch.

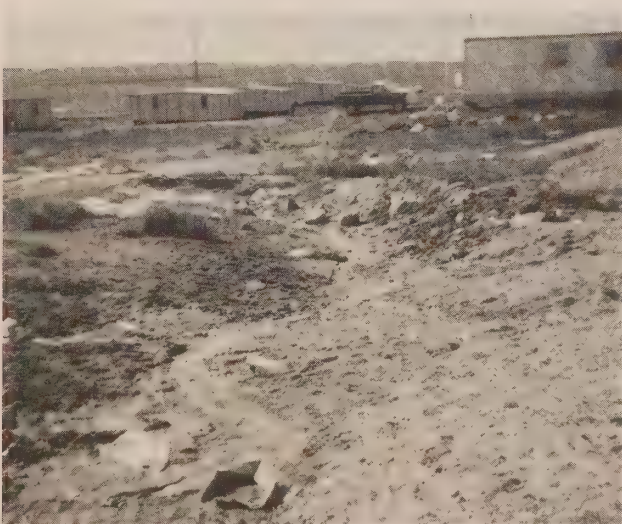
PHOTO BL-12 – Drainage course.

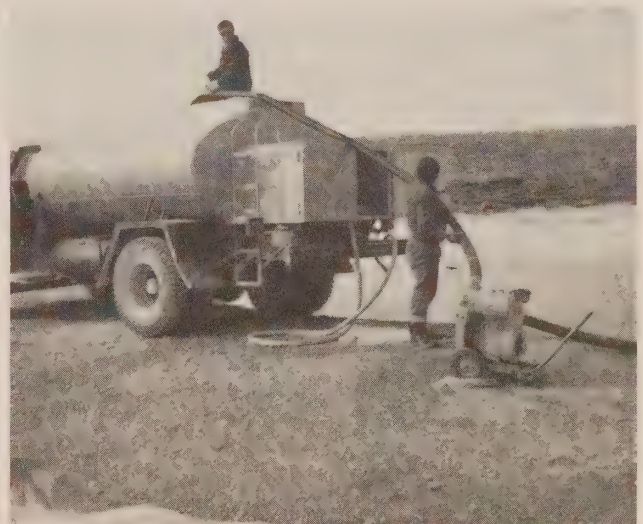
During the site inspection, water was being taken from Water Lake, near the upper air station (Photo CB-1).

PHOTO CB-1 – Water truck filling at Water Lake.

It is pumped by a 10-hp. gas-operated pump through a 20 foot-long, 4 inch diameter rubber hose into the top of a 1500-gallon tank truck. The truck's pump is powered by the transmission, and the 2-inch diameter, 50-foot, rubber hose with control nozzle is automatically reeled up between deliveries. The truck has a Neptune Print-o-Matic register, which shows the amount delivered to each household and also permits ticket printing after each delivery.

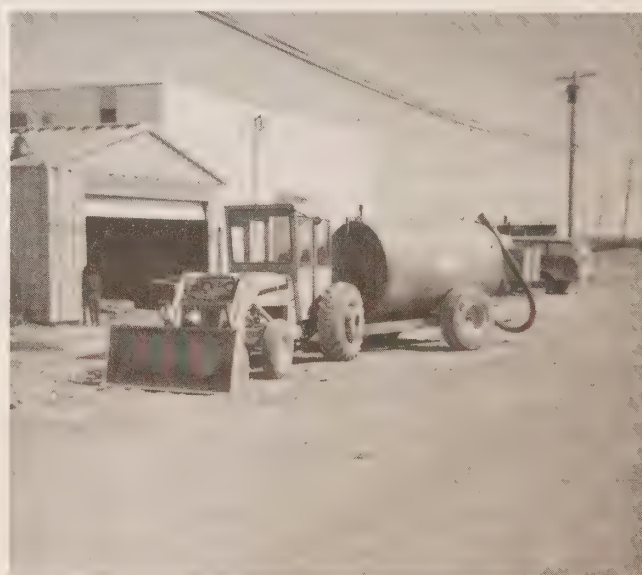
The liquid effluent is hauled in a two-wheeled Beatty tank trailer with a 1200 gallon capacity, pulled by a Massey Ferguson Model 200 loader (Photo CB-2). Sewage is pumped into and out of the tank by means of an air pump within the tank, which provides pressure or vacuum. The pump is driven by a power take-off from the loader.

PHOTO CB-2—Tractor and sewage pumpout tank.

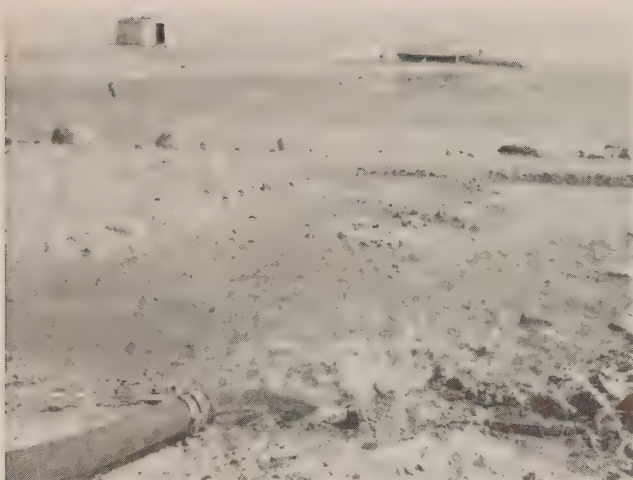
PHOTO CB-3—Dumping of sewage on gravelled berm beside bay

Effluent is dumped by gravity into what passes for a gravelled detention lagoon of 30 ft by 300 ft (with small berm) on the shore of the bay about 2,000 ft past the MOT complex on the road to the airport (Photo CB-3). It was not possible to estimate accurately the detention time; on inspection, it was noted that the greater portion of a 500 gallon load had disappeared by the next dumping, about one hour later.

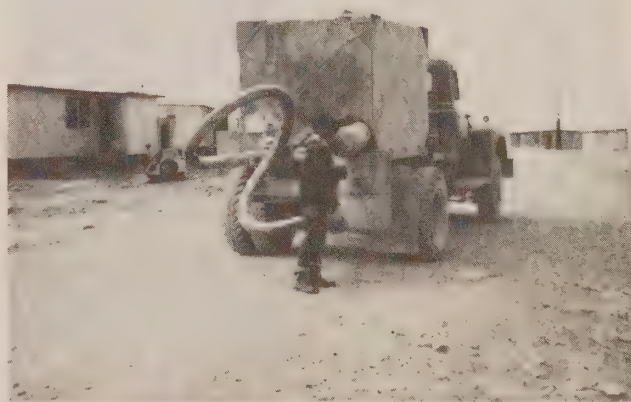
PHOTO CB-5—Dumping honey bag into suction drum.

When the honey bags are dumped into the drum, there is splashing and splattering onto the truck, road, and workman. The bags are often extremely full, and sometimes contain beer cans and other garbage (a strainer has been fitted to the hose to catch large items in the drum before they are sucked into the tank). The method of dumping is at least moderately offensive to the workmen on the truck.

- Replace the bathroom collection by a service-porch honey bag collection with two pails to a household.
- Improve the honey bag collection by :  
A device for ripping of bags in 40-gallon sucking drum to minimize spilling, and time needed.
- The use of continuous pumping equipment to prevent sloshing and spilling from a full drum.
- Consider Ross's proposal for installation of holding tanks provided that :
  - the system would be compatible with the proposed utilidor system.
  - the contract specifies twice-weekly pumpout of the 60-gallon tanks, or increase the size of the tank.

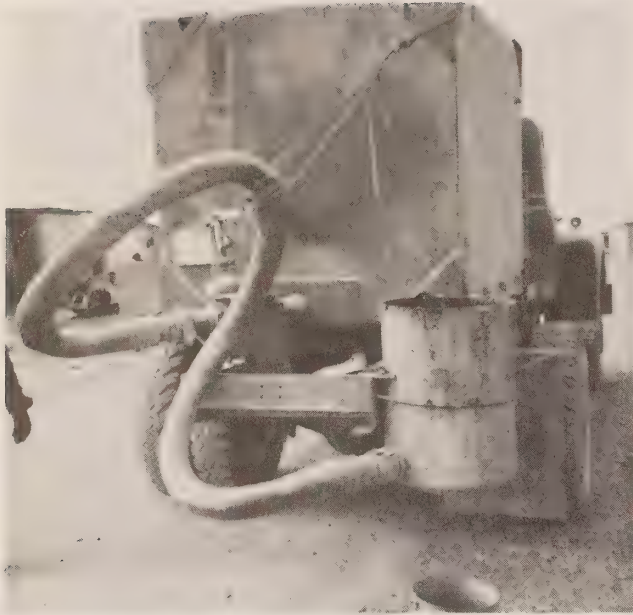
PHOTO CB-6—Rear view of honey bag suction vehicle.

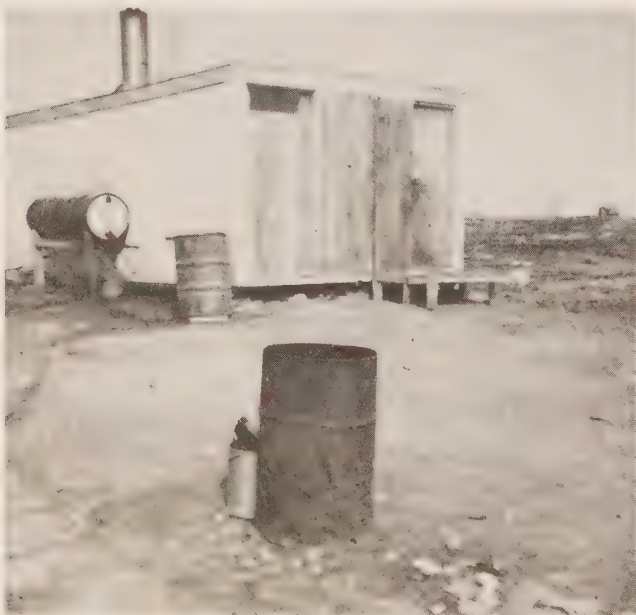
There has been considerable public objection to the new collection system, which was written into the contract without consulting government officials or residents in Cambridge Bay. Many householders object to the honey bag collectors trooping through their homes to the bathroom, as inconvenient, messy, and as an invasion of privacy. Some place the pails on their service porches, but a few who object to the in-house collection continue to place the bags in or beside the 45-gallon drums in front of their homes (Photo CB-7).

PHOTO CB-7—Garbage and honey bag on street in front of "370" home.

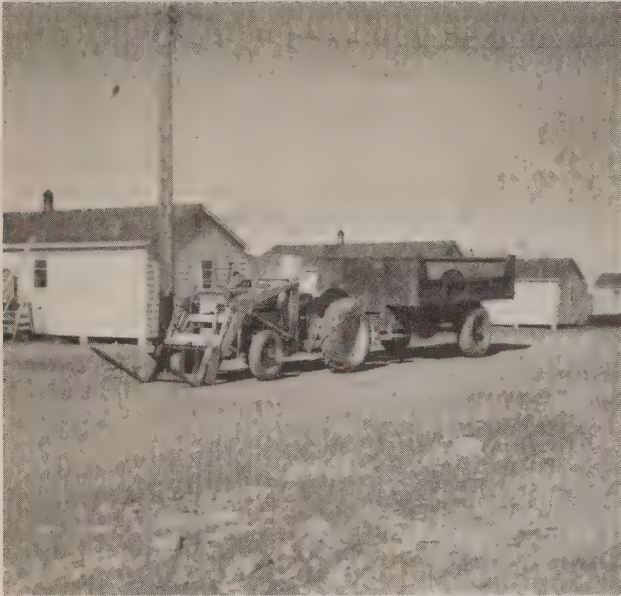
Garbage is collected once a week by Ross Associates. The 45-gallon drums in front of each home are placed in an open, four-wheeled cart pulled by a Ford 2000 tractor with fork lift (Photo CB-8). The preliminary contract specifications called for the collection of garbage in a packer-type van or other enclosed vehicle, transport of garbage to dump, maintenance of the dump site, the segregation and burning of all combustibles every 30 days, and the bulldozing of the dump with gravel or other earth fill once every month.

PHOTO CB-8—Tractor and garbage collection cart.

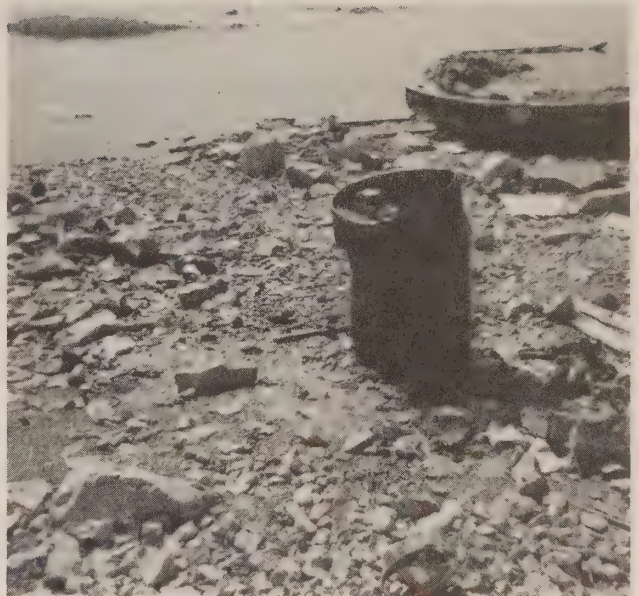
There is considerable litter of every description, including metal, construction equipment and material, usable wood and electrical wire. The beach is littered with honey bags, construction equipment and materials, and oil drums (Photo CB-9). Many snowmobiles have been abandoned on the ice in the bay.

PHOTO CB-9—The beach.

- The clean-up of the town should include unsightly, hazardous refuse along the beach, in the light industrial area, and on the bay ice.

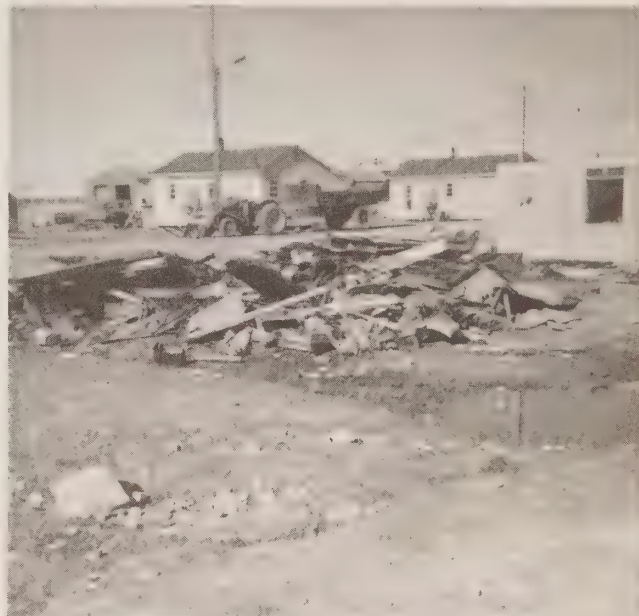
In the winter of 1970, a fire in a low-rental unit was extinguished by bulldozing in the walls of the building (Photo CB-12).

PHOTO CB-12 – This home was bulldozed when it caught fire last winter.

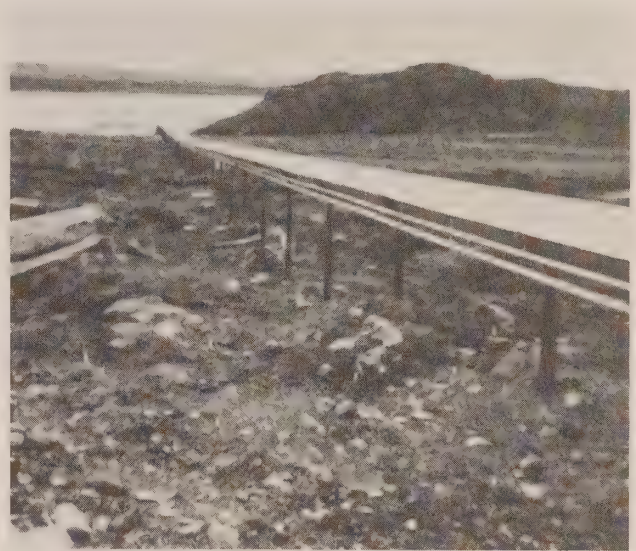
By April of 1970 the Northern Canada Power Commission built a \$250,000 water treatment plant and utilidor system for the Territorial government. A 420-foot utilidor in a diamond-shaped aluminum box (Photo C-1) leads from the Coppermine River to the treatment plant. A 10-horsepower, 575-volt Sangamo "Peerless" pump in a seven foot square wooden pumphouse beside the river provides the 70 psi pressure required to lift the water 100 feet to the treatment plant.

PHOTO C-1 — Supply utilidor.

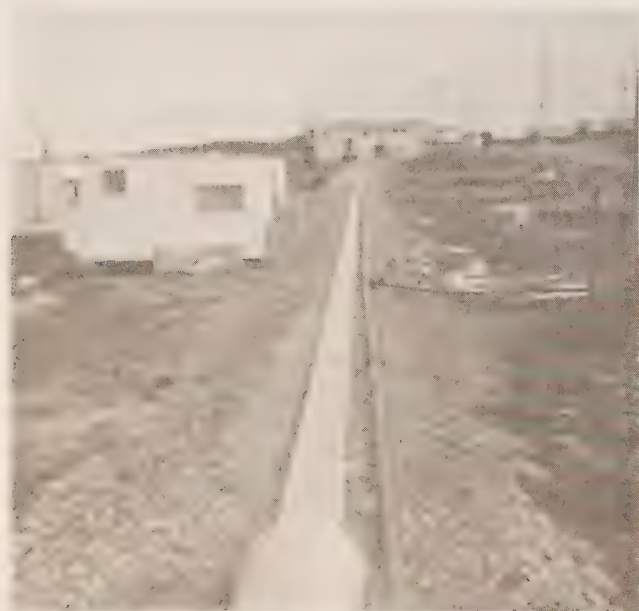
Water is provided to the settlement by four-inch vic-taulic pipe enclosed in a styrofoam-insulated six-inch square aluminum box utilidor supported on a gravel pad (Photo C-2). The nursing station, three homes

PHOTO C-2—Delivery utilidor.

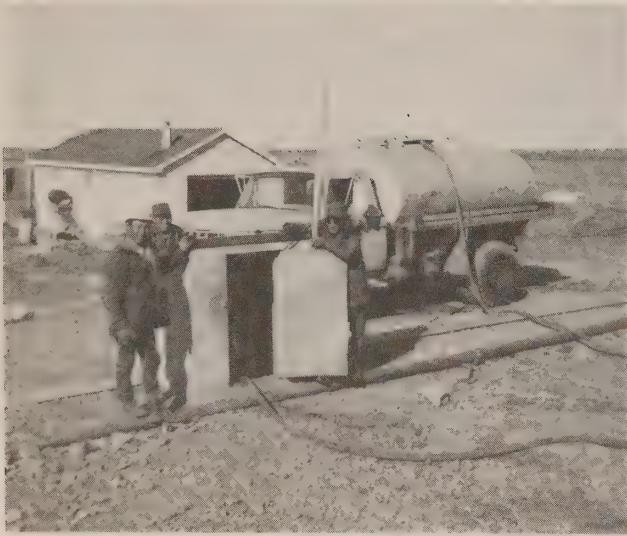
Water is delivered to all homes by Territorial employees. The tank truck is filled from the utilidor on the road between the nursing station and the school by placing the nozzle from a three-inch diameter rubber hose into the top of the truck (Photo C-3). The tank takes 10 to 12 minutes to fill. The hose is stored in a three foot cube wooden box which also houses the valve and connection to the utilidor; however, on two occasions during the site visit, the hose with its attached nozzle was observed lying in a puddle of water beside the garbage and honey bag cans in front of a nearby home. On 22 June 1971 a pail of Javex and water for storage of the nozzle was installed in the box.

PHOTO C-3—Water truck filling at utilidor.

and stop the gasoline fueled water pump. Although the operators were making an effort to prevent the nozzle from falling to the ground, it often did so and several times was dragged through the numerous puddles surrounding some of the houses.

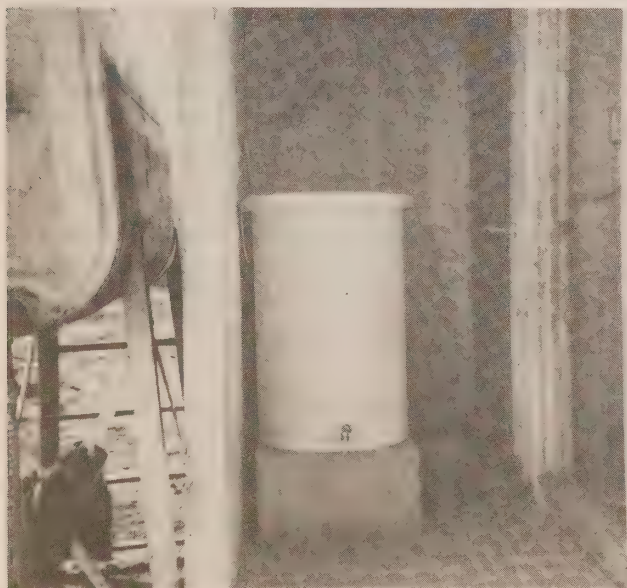
On Tuesdays and Thursdays water is delivered to the 105 low rental native housing units. Most homes have 45-gallon plastic water tanks in the kitchen, but in the summer many move their tanks into the service room or porch (Photo C-4) depending on the model of the house. Tanks cannot be stored in service rooms in

PHOTO C-4—45 gallon plastic tank in service porch.

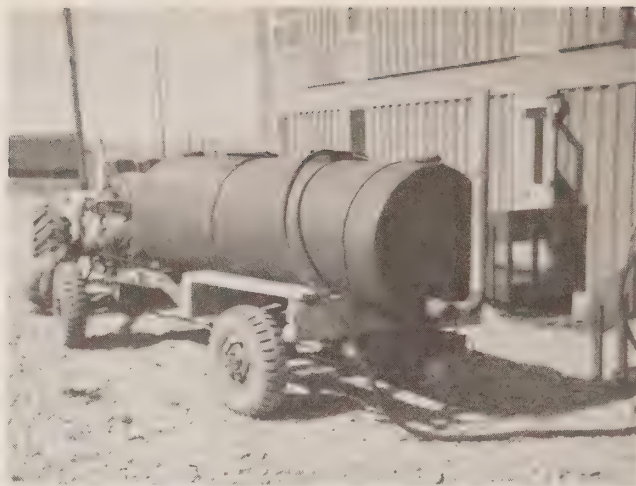
PHOTO C-5—Sewage pumpout tank.

behind the tractor to collect liquid sewage (Photo C-5). The tank has a 1,000-gallon capacity. Sewage is fed through hatches in the top, and ejected by a standpipe in the rear.

The co-op should be encouraged to purchase a larger vehicle for sewage collection, with a spill-proof drain and sealable intake opening to prevent effluent leakage during transport. This vehicle might also incorporate a ripping chute for honey bags, as recommended earlier.

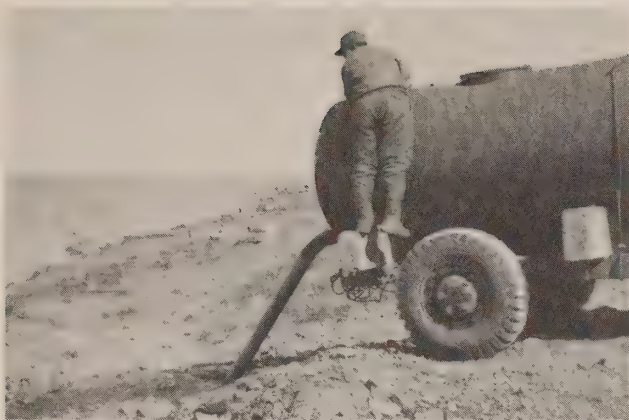
PHOTO C-6—Dumping of sewage effluent at gulf.

and into the bay (Photo C-6). George Woodget, environmental health officer, felt that this was inimical to the marine life of the bay, and that some thought should be given to disposing of liquid effluent at the dump site.

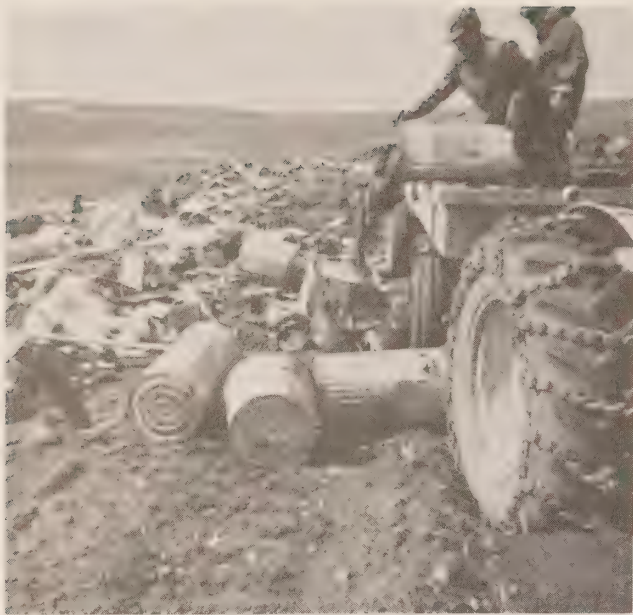
On the three occasions when garbage and honey bag pickup was observed, it was noted that fewer than one household in two placed honey bags out for pickup. Householders come to the co-op for empty honey bags when they run out. Apparently the bags distributed by the co-op are often used for other purposes. Honey bags are dumped along with the garbage in the disposal area, one and one quarter miles from town on the airstrip road. Some bags break and splash their contents when dumped out of the pails from the trailer (Photo C-7); most, however, fall unpunctured. The honey bags are dumped immediately beside the trailer, so that those which do break splash their contents over the wheels and underside of the collection equipment.

PHOTO C-7—Dumping of honey-bags and garbage.

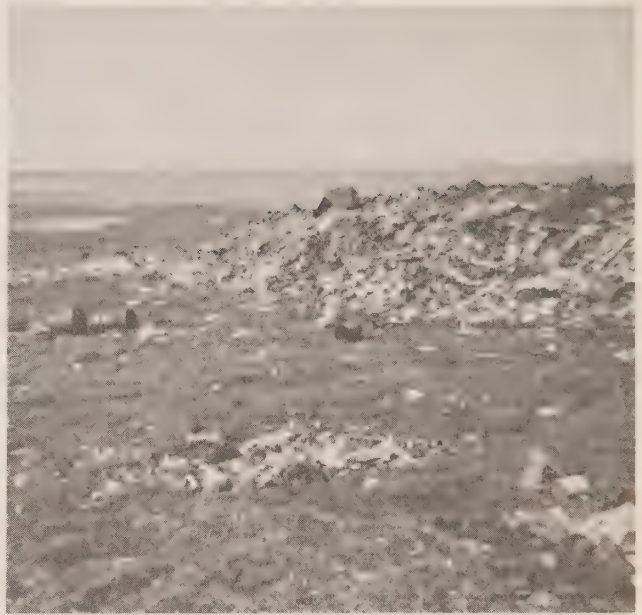
PHOTO C-8—Dump slope.

The dump is one and a quarter miles from town along the airport road. As previously noted, honey bags and garbage are dumped together. A slope of garbage has been created over an area of approximately two acres (Photo C-8). The tractor-trailer drives to within 30 feet of the 400-foot wide lip of the hill and the garbage

The dump-site should be immediately reduced in size by bulldozing into a smaller area with a dump slope no more than 100 feet wide. It should be compacted and covered with earth regularly. The garbage contractor should be supervised so that the dump does not again deteriorate to its present state.

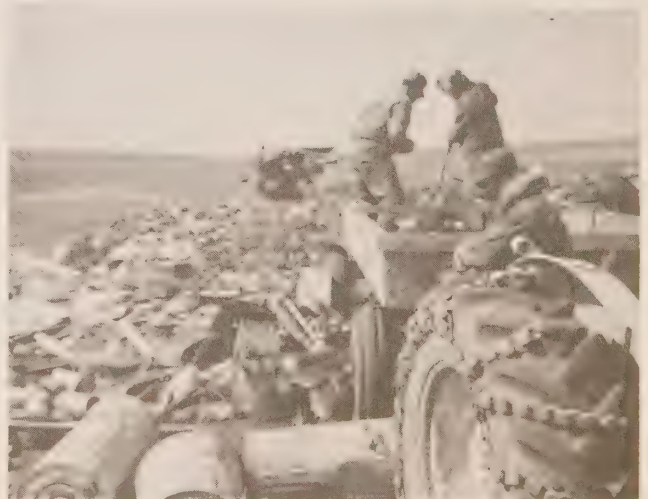
shovelled or removed by hand from the trailer (Photo C-9). Although there was good gravel and earth for cover and fill across the road from the dump, it appeared to have been at least a month since the dump was bulldozed. Maintaining the disposal area is the responsibility of the settlement government. A ridge separates the marshy area at the base of the garbage hill from the bay. Much of the paper rubbish had been scattered by wind over a marshy area about 20 acres in extent west and north of the dump. The 200-foot long access road is heavily littered with cans, paper and other garbage. In the opinion of environmental health officer, the dump area should be confined to a 100-foot wide strip and greater effort should be made to properly dump, backfill, and bulldoze the disposal site.

PHOTO C-9—Shovelling of garbage.

The co-op should be encouraged to purchase a proper dumping vehicle to replace the garbage cart. This would result in increased speed, efficiency, and more sanitary garbage disposal.

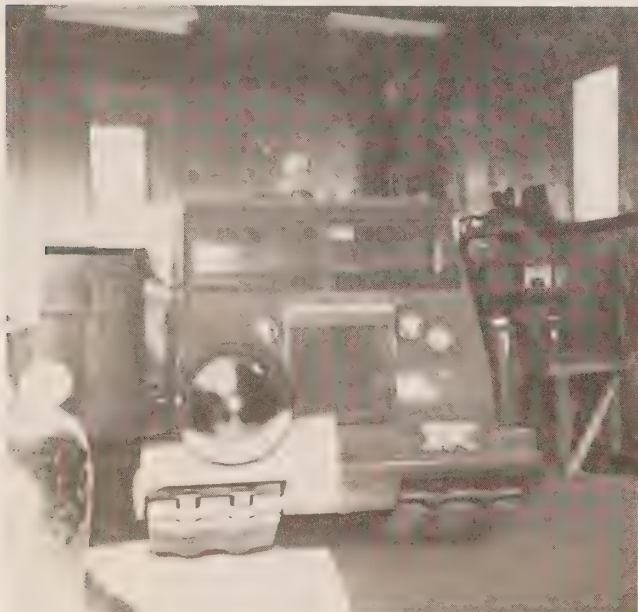
The fire fighting vehicle is a Bombardier "Track-Master" (Photo C-12) purchased from Coutts Machinery, Calgary for \$17,000 in 1968. It has a 500-gallon tank capacity. During a fire on 1 January 1971, pipes on the truck froze and cracked; however, they have been taped and are allegedly usable. This vehicle apparently lacked sufficient power to climb a small hill during a fire last winter, and members of the settlement council agreed that in a fire the water trucks provided better mobility and greater water supply than did the tracked vehicle.

PHOTO C-12—Fire vehicle.

The Bombardier Trackmaster should be replaced by a tank truck vehicle similar to the one purchased at Rae for \$19,000.

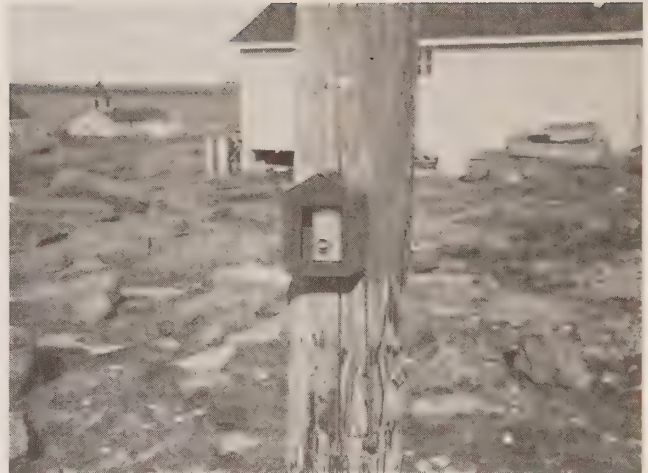
PHOTO C-13—Fire alarm box.

There is 300-pound dry-chemical unit in a compartment on the fire vehicle. The town is equipped with an Edwards fire alarm system with siren and 15 alarm boxes on the streets (Photo C-13). The siren is used to sound the nightly 9:45 p.m. curfew and 7:45 a.m. reveille. A central panel in the fire station indicates which alarm has been pushed. It was stated that under some wind conditions, the siren is not audible in the town near the MOT complex. The NCPC installation, nursing station, and new school have their own building alarm systems with reset panels.

- The inoperative red indicator lamps above fire alarm boxes should be replaced to allow easy identification of fire alarms during winter darkness.
- Through the night water vehicles should be kept full in case of fire.

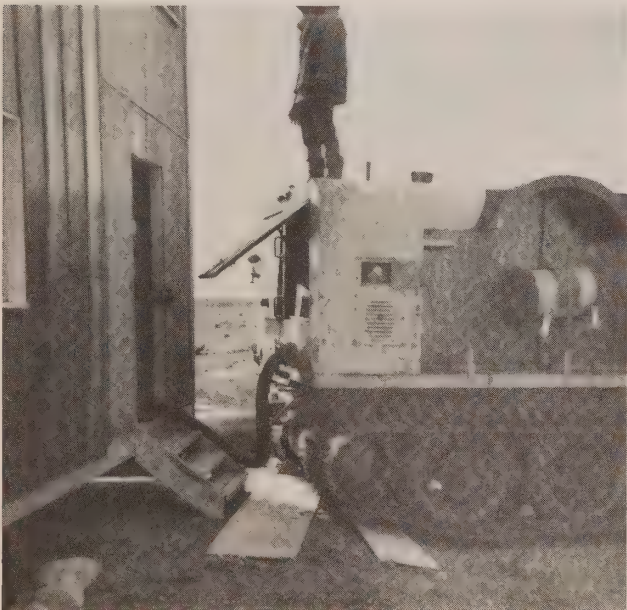
PHOTO EP-4—Sewage pumpout vehicle.

- The ejector pump on the Nodwell RN75 should be used so as to prevent sewage (spilling on the sides and tracks of the vehicle) from being tracked back into the settlement.
- In view of damage to the area and the remote possibility of contamination of the water supply, the present alleged practice of dumping sewage on the tundra outside the settlement should be abandoned.

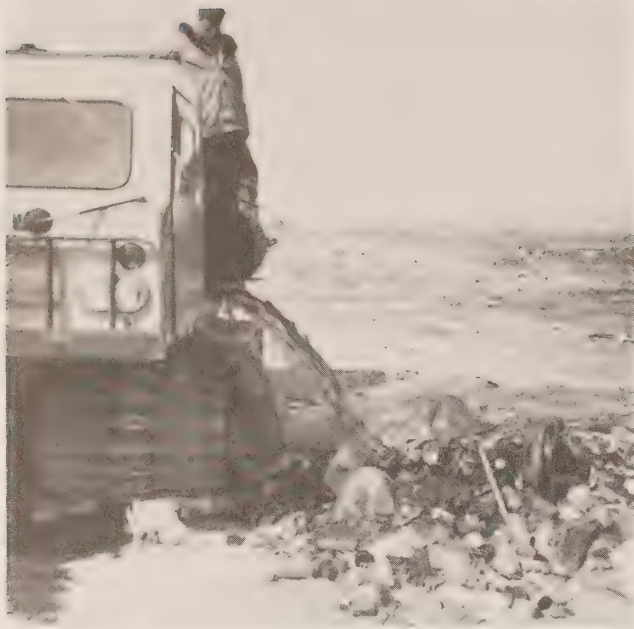
It was reported that sewage was ordinarily dumped in the tundra 1500 feet south of the observed disposal area. An examination of the area revealed Nodwell RN75 tracks leading to an extensive, very swampy area of tundra stained by sewage (Appendix A). It was not possible to determine when dumping had occurred, and no observation of dumping was made. Residents suggested that this dumping area drains into the water supply lake.

PHOTO EP-5—Dumping of sewage by gravity.
